**Flood Control Project Maintenance
Levee Inspections**

Fall 2013 Levee Maintenance Deficiency Summary Report

Fall 2013 Levee Inspection Results

Reclamation District No. 0544 Upper Roberts Island

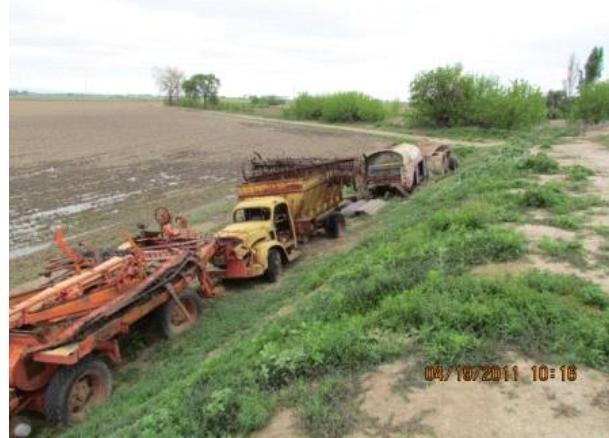
Levee Mile Report Line	5
Start Levee Mile	0.23
End Levee Mile	0.23
Location	Land Side
Category	Earthen Levee
Item	Encroachments
Looking south at equipment along landside toe.	
richard_f_20130930_924.jpg

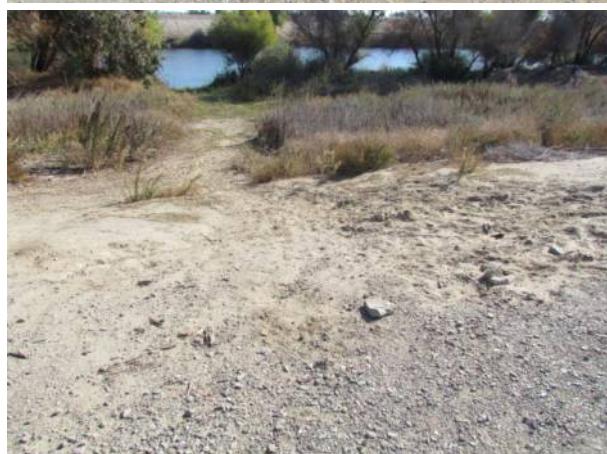
Levee Mile Report Line	21
Start Levee Mile	1.56
End Levee Mile	1.56
Location	Water Side
Category	Earthen Levee
Item	Slope Stability
Looking east at damaged waterward slope.	
richard_f_20131030_139.JPG

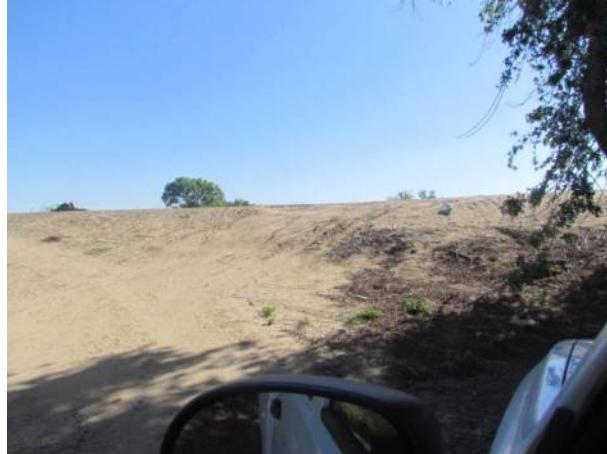
Levee Mile Report Line	26
Start Levee Mile	1.83
End Levee Mile	1.83
Location	Land Side
Category	Earthen Levee
Item	Slope Stability
Looking east at landward slope damaged by vehicle traffic.	
richard_f_20130930_926.JPG

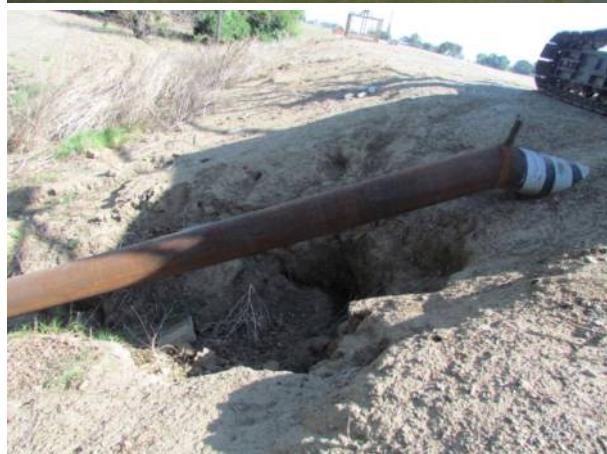
Levee Mile Report Line	29
Start Levee Mile	2.01
End Levee Mile	2.01
Location	Water Side
Category	Supplemental
Item	DWR Erosion Survey
Front view of erosion.	
SJR2013_RD0544U01RM48.81_3.jpg

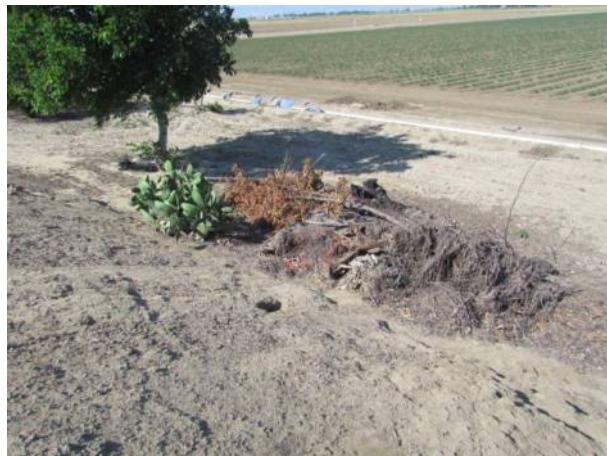
Levee Mile Report Line	33
Start Levee Mile	2.34
End Levee Mile	2.34
Location	Land Side
Category	Earthen Levee
Item	Encroachments
Looking southwest at garbage at landside toe.	
richard_f_20130930_927.jpg

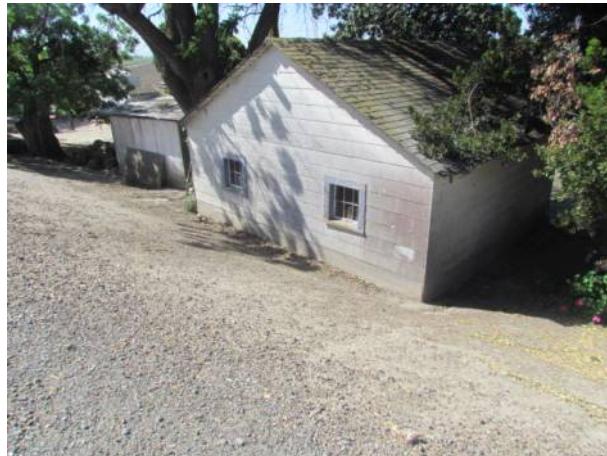
Levee Mile Report Line	36
Start Levee Mile	2.40
End Levee Mile	2.40
Location	Land Side
Category	Earthen Levee
Item	Encroachments
Looking southeast at building at landward toe.	
richard_f_20130930_961.JPG

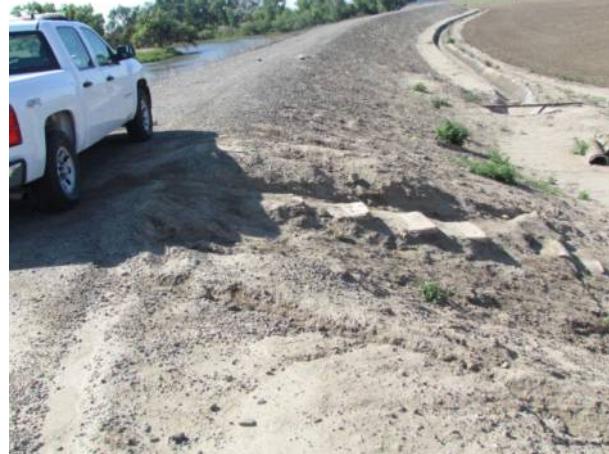
Levee Mile Report Line	38
Start Levee Mile	2.58
End Levee Mile	2.58
Location	Land Side
Category	Earthen Levee
Item	Slope Stability
Looking south at slope damage on landside slope.	
<i>richard_f_20130930_956.jpg</i>

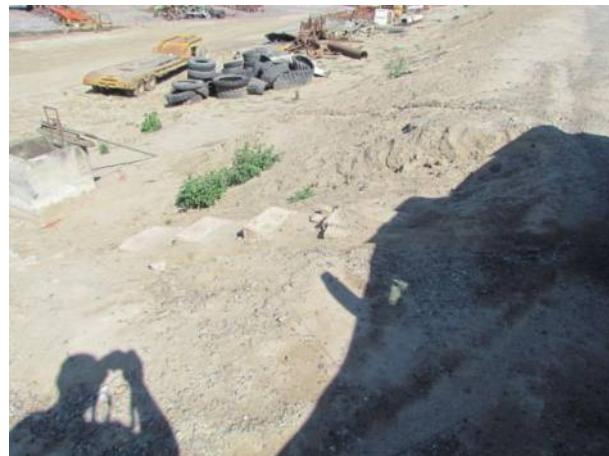
Levee Mile Report Line	38
Start Levee Mile	2.58
End Levee Mile	2.58
Location	Land Side
Category	Earthen Levee
Item	Slope Stability
Looking north at slope damage on landside slope.	
<i>richard_f_20130930_957.jpg</i>

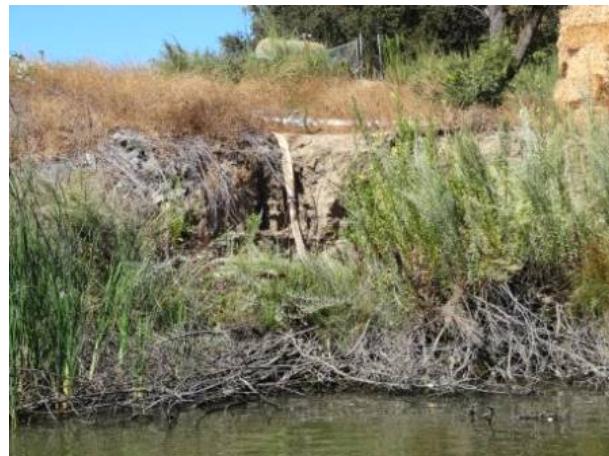
Levee Mile Report Line	41
Start Levee Mile	2.94
End Levee Mile	2.94
Location	Water Side
Category	Supplemental
Item	DWR Erosion Survey
Close view of the site. Erosion has worsened and more vegetation is visible.	
<i>SJR2013_RD0544U01RM49.67_2.jpg</i>

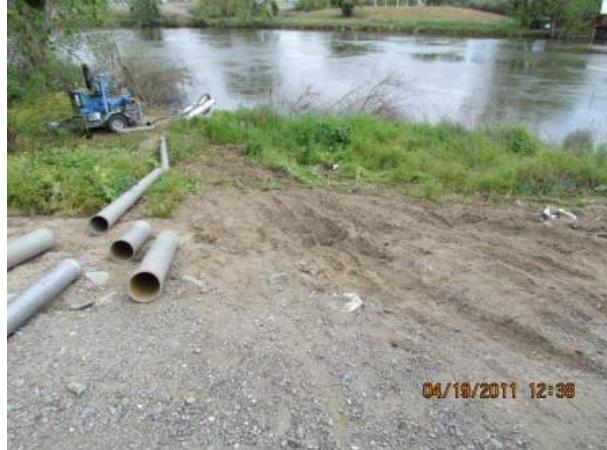
Inspector Comments: Landowner installing temporary irrigation system across levee crown without permit. Pipe is leaking and causing erosion on waterside slope and berm.	-121.318370 °	-121.318370 °	Y	
										DWR ID: DWR_RD0544_01_s_2012_16	
44	2.98	2.98	Earthen Levee	Erosion / Bank Caving	WS Ma	M	E2 : Schedule repair of erosion site prior to the next inspection.	°	°	75	
							Inspector Comments: Hole on levee crown shoulder. Hole is 16"x18"x24. Hole is undermining back toward landward slope.	°	°	Y	
										DWR ID: DWR_RD0544_01_f_2013_75	
45	3.15	3.15	Earthen Levee	Slope Stability	WS Ma	M	S1 : Repair slope instability.	37.837929 °	37.837929 °	76	
							Inspector Comments: Slope damaged extends from levee slope to shoulder.	-121.317663 °	-121.317663 °	Y	
										DWR ID: DWR_RD0544_01_f_2013_76	
46	3.19	3.19	Earthen Levee	Slope Stability	WS Ma	M	S2 : Repair the levee slope damaged by foot traffic and prevent access where possible.	37.837530 °	37.837530 °	62

Levee Mile Report Line	43
Start Levee Mile	2.98
End Levee Mile	2.98
Location	Land Side
Category	Earthen Levee
Item	Encroachments
Looking east at landowner installing temporary pump system without permit and damage to waterside slope.	
richard_f_20130930_928.jpg

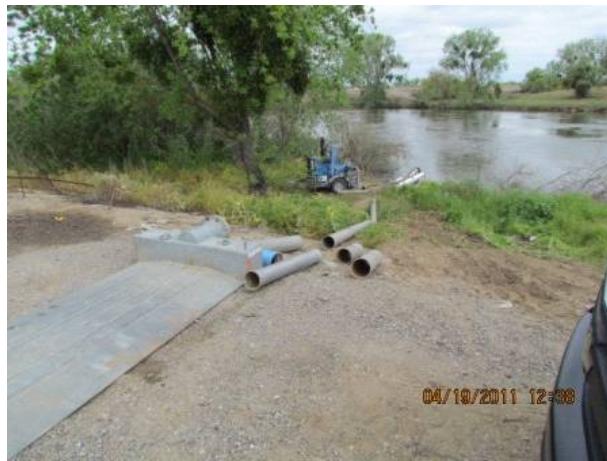
Levee Mile Report Line	43
Start Levee Mile	2.98
End Levee Mile	2.98
Location	Land Side
Category	Earthen Levee
Item	Encroachments
Looking east at pump and irrigation ramp on levee waterside and crown.	
richard_f_20130930_929.jpg

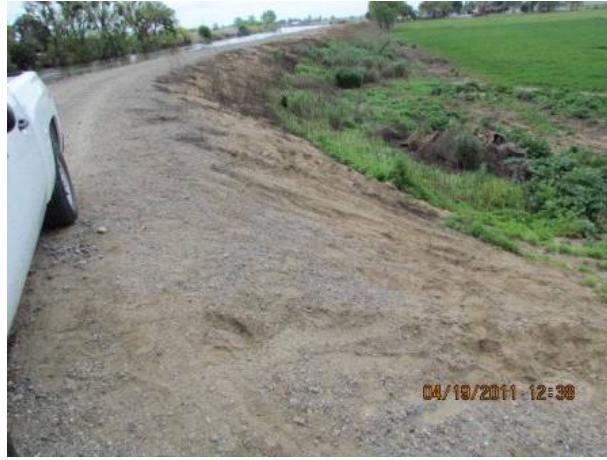
Levee Mile Report Line	43
Start Levee Mile	2.98
End Levee Mile	2.98
Location	Land Side
Category	Earthen Levee
Item	Encroachments
Looking south at damage landside slope caused by vehicle traffic.	
richard_f_20130930_930.jpg

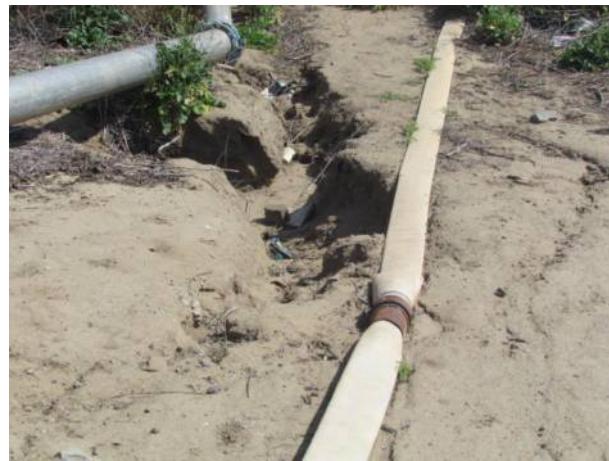
Levee Mile Report Line	43
Start Levee Mile	2.98
End Levee Mile	2.98
Location	Land Side
Category	Earthen Levee
Item	Encroachments
Looking east at erosion caused by leaking pipe on waterside slope.	
richard_f_20130930_932.jpg

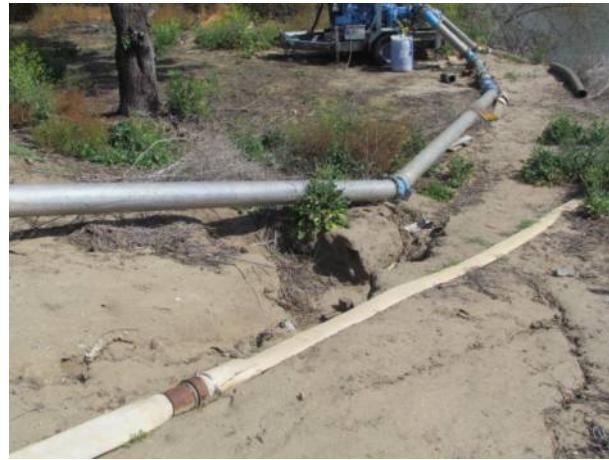
Levee Mile Report Line	43
Start Levee Mile	2.98
End Levee Mile	2.98
Location	Land Side
Category	Earthen Levee
Item	Encroachments
Looking northeast at unauthorized pump system on waterside slope.	
richard_f_20130930_933.jpg

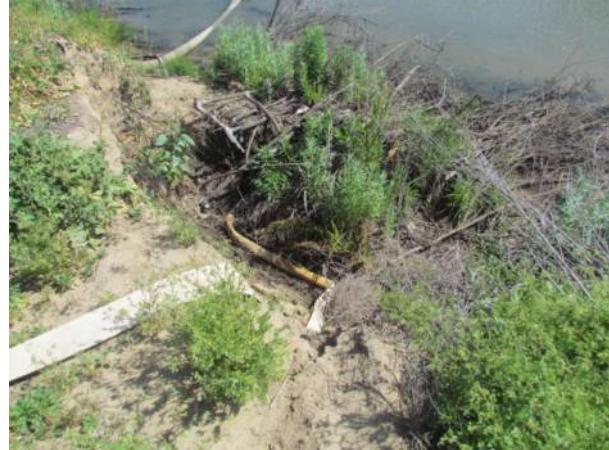
Levee Mile Report Line	43
Start Levee Mile	2.98
End Levee Mile	2.98
Location	Land Side
Category	Earthen Levee
Item	Encroachments
Looking east at erosion caused by leaking hose on waterward berm. (Spring 2013)	
richard_f_20130930_934.JPG

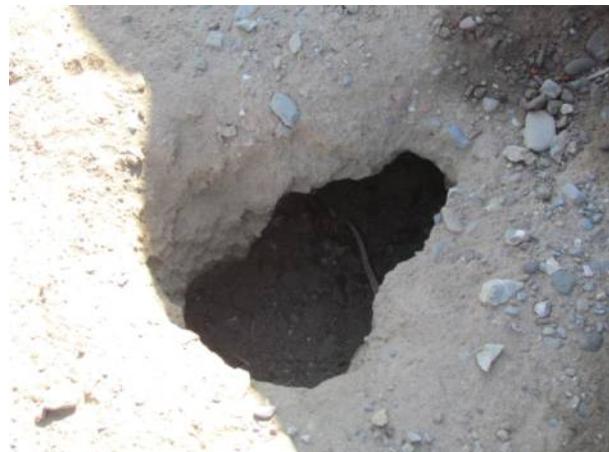
Levee Mile Report Line	44
Start Levee Mile	2.98
End Levee Mile	2.98
Location	Water Side
Category	Earthen Levee
Item	Erosion / Bank Caving
Looking at large hole on waterward shoulder.	
richard_f_20131030_140.JPG

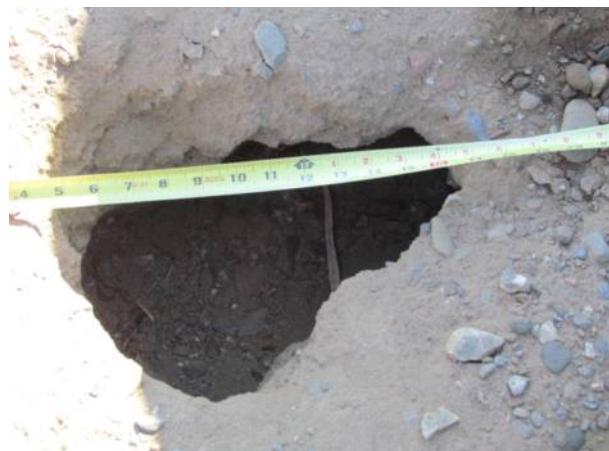
Levee Mile Report Line	44
Start Levee Mile	2.98
End Levee Mile	2.98
Location	Water Side
Category	Earthen Levee
Item	Erosion / Bank Caving
Looking at hole on waterward shoulder.	
richard_f_20131030_141.JPG

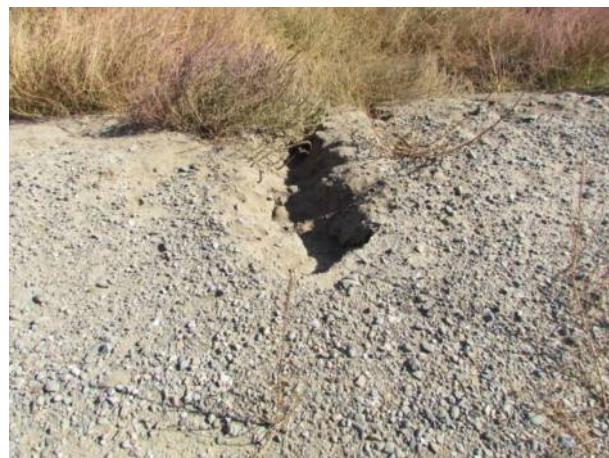
Levee Mile Report Line	45
Start Levee Mile	3.15
End Levee Mile	3.15
Location	Water Side
Category	Earthen Levee
Item	Slope Stability
Looking east at slope damage on waterward slope.	
richard_f_20131030_143.JPG

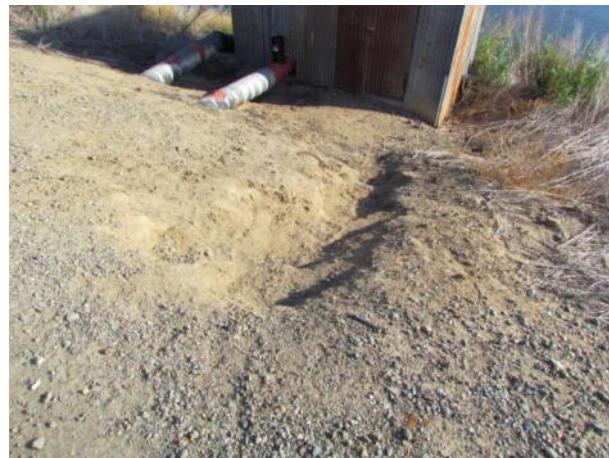
Levee Mile Report Line	46
Start Levee Mile	3.19
End Levee Mile	3.19
Location	Water Side
Category	Earthen Levee
Item	Slope Stability
Looking east at slope damaged by foot traffic near pump house on waterside of levee.	
richard_f_20130930_958.JPG

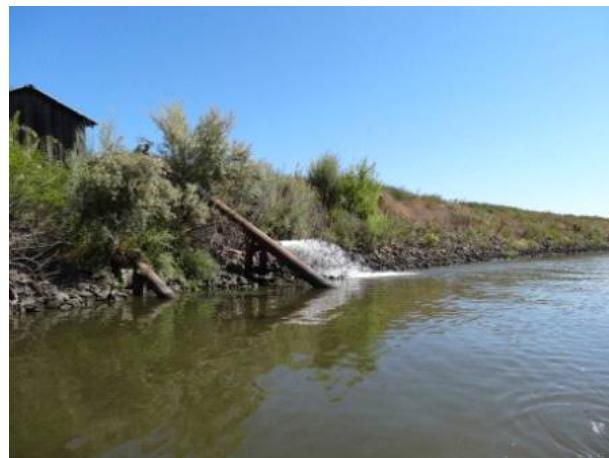
Levee Mile Report Line	57
Start Levee Mile	4.21
End Levee Mile	4.22
Location	Water Side
Category	Supplemental
Item	DWR Erosion Survey
Close view of the site.	
SJR2013_RD0544U01RM51.04_2.jpg

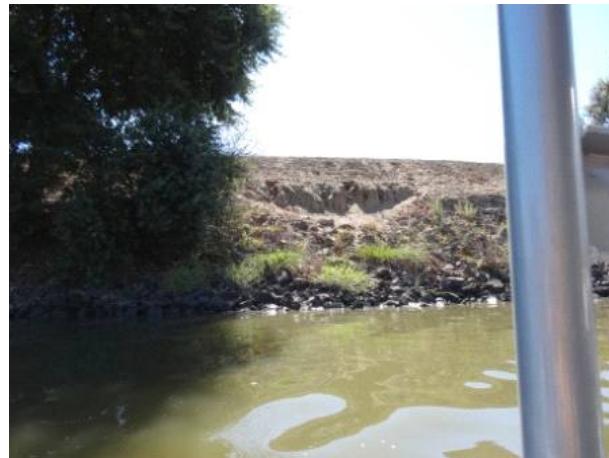
Levee Mile Report Line	59
Start Levee Mile	4.32
End Levee Mile	4.32
Location	Water Side
Category	Supplemental
Item	DWR Erosion Survey
Looking from upstream at the site.	
SJR2013_RD0544U01RM51.09_1.jpg

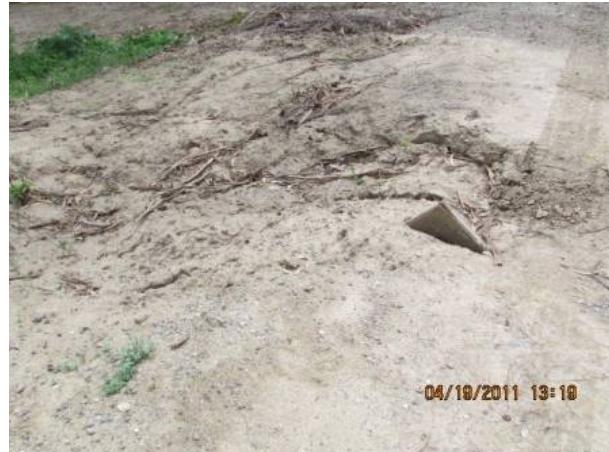
Levee Mile Report Line	62
Start Levee Mile	4.33
End Levee Mile	4.33
Location	Crown
Category	Earthen Levee
Item	Crown Surface / Depressions / Rutting
Looking southeast at depression on waterside shoulder.	
richard_f_20130930_955.jpg

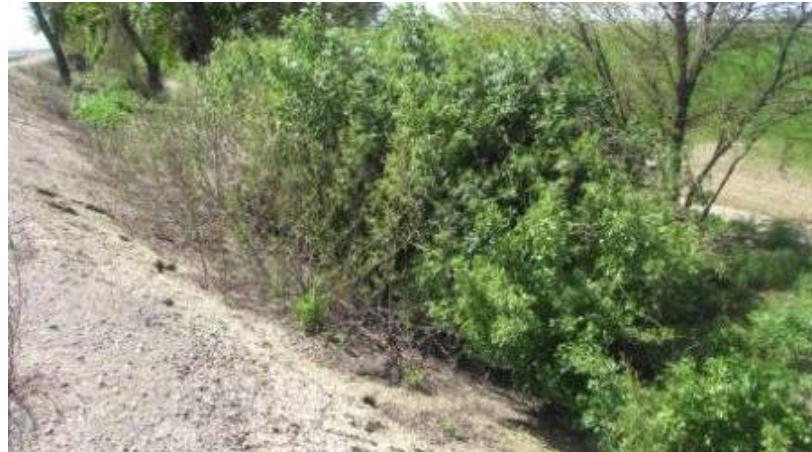
Levee Mile Report Line	65
Start Levee Mile	4.53
End Levee Mile	4.53
Location	Land Side
Category	Earthen Levee
Item	Vegetation
Looking south at elderberries on landside slope and toe.	
richard_f_20130930_946.jpg

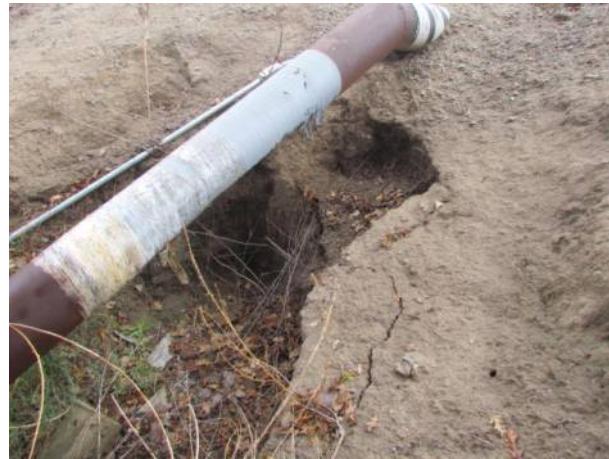
Levee Mile Report Line	67
Start Levee Mile	4.75
End Levee Mile	4.75
Location	Land Side
Category	Earthen Levee
Item	Slope Stability
Looking northeast at erosion around irrigation pipe on landside slope.	
richard_f_20130930_940.jpg

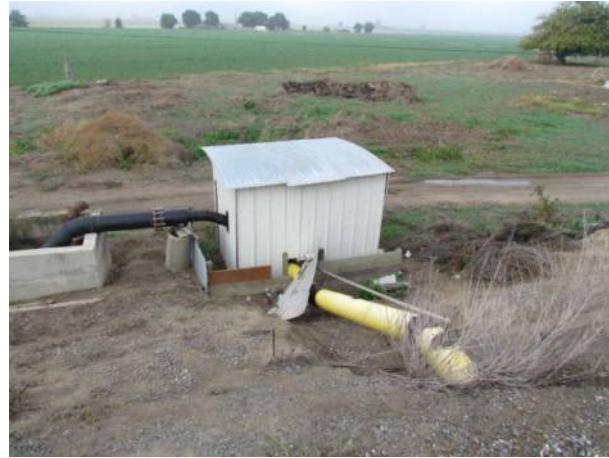
Levee Mile Report Line	70
Start Levee Mile	4.78
End Levee Mile	4.78
Location	Land Side
Category	Earthen Levee
Item	Encroachments
Looking west at a unauthorized pump house on landside toe.	
richard_f_20130930_947.jpg

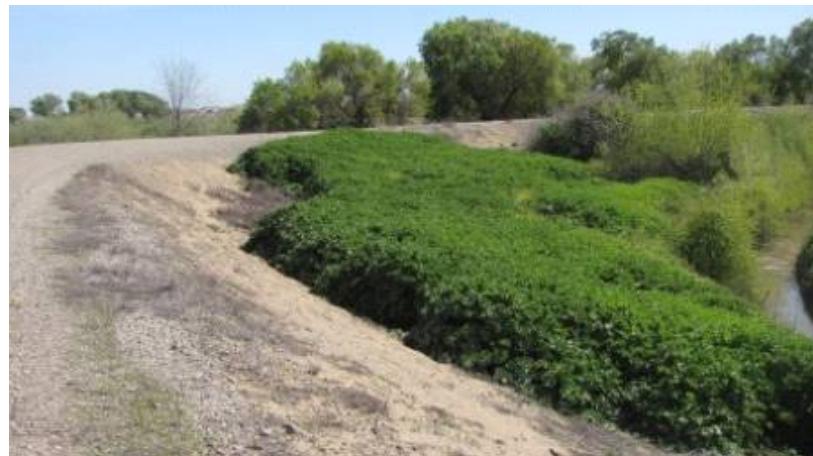
Levee Mile Report Line	75
Start Levee Mile	5.00
End Levee Mile	5.30
Location	Land Side
Category	Earthen Levee
Item	Vegetation
Looking southeast at dense veg. on landside slope and toe.	
richard_f_20130930_941.jpg

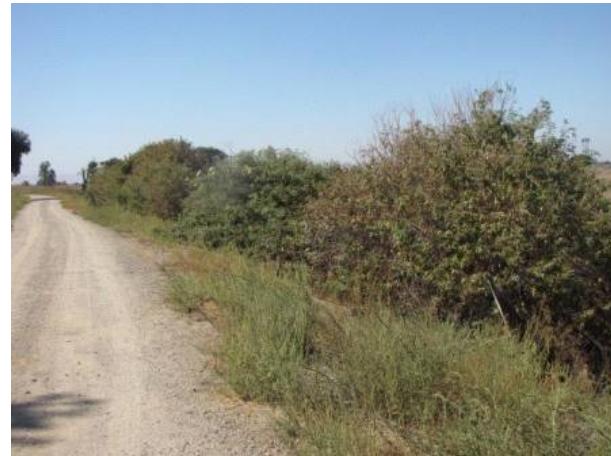
Levee Mile Report Line	78
Start Levee Mile	5.54
End Levee Mile	5.60
Location	Land Side
Category	Earthen Levee
Item	Vegetation
Looking southwest on elderberries on landside slope and toe.	
richard_f_20130930_935.jpg

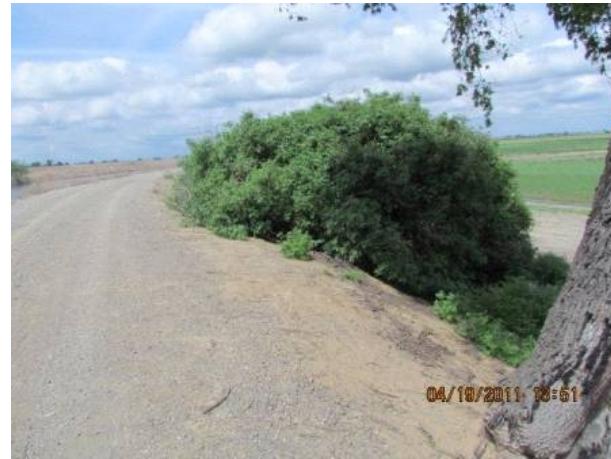
Levee Mile Report Line	2
Start Levee Mile	0.41
End Levee Mile	0.41
Location	Land Side
Category	Earthen Levee
Item	Vegetation
Looking south at elderberries on landside slope.	
richard_f_20130930_964.jpg

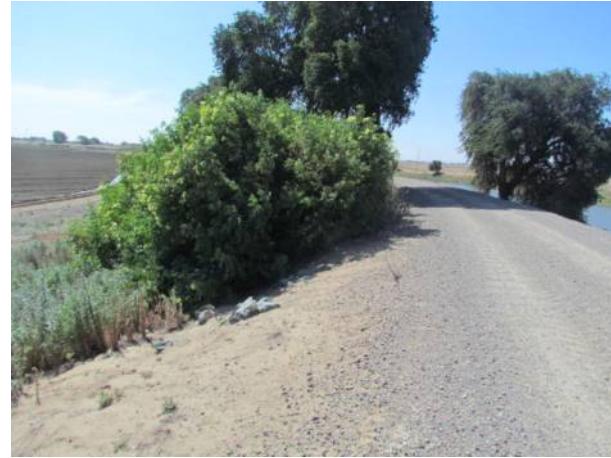
Levee Mile Report Line	2
Start Levee Mile	0.41
End Levee Mile	0.41
Location	Land Side
Category	Earthen Levee
Item	Vegetation
Looking northwest at elderberry on landside slope. (Spring 2012)	
richard_f_20130930_965.jpg

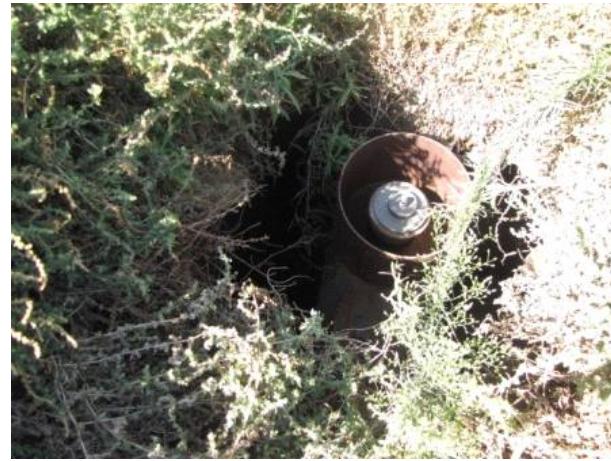
Levee Mile Report Line	7
Start Levee Mile	0.79
End Levee Mile	0.79
Location	Water Side
Category	Interior Drainage & Piping Systems
Item	Erosion Areas
Looking at top of siphon on waterside shoulder with 3' of caving around pipe.	
richard_f_20130930_968.jpg

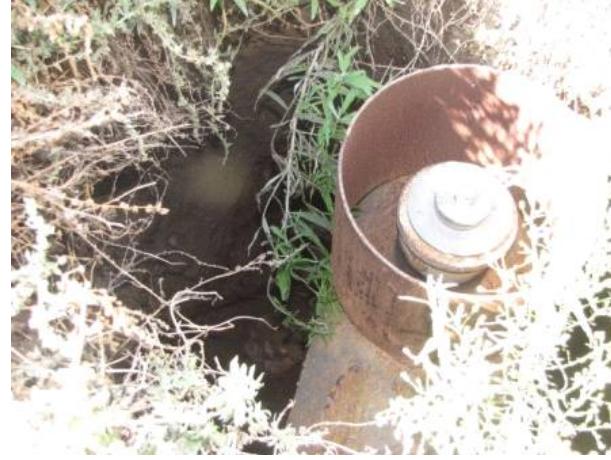
Levee Mile Report Line	7
Start Levee Mile	0.79
End Levee Mile	0.79
Location	Water Side
Category	Interior Drainage & Piping Systems
Item	Erosion Areas
Looking at caving around 10" siphon pipe on waterside shoulder.	
richard_f_20130930_969.jpg

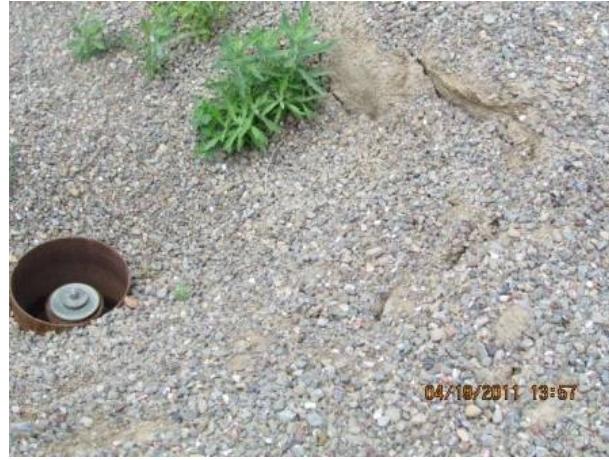
Levee Mile Report Line	7
Start Levee Mile	0.79
End Levee Mile	0.79
Location	Water Side
Category	Interior Drainage & Piping Systems
Item	Erosion Areas
Looking at top of siphon with a depression greater than 6" on waterside shoulder.	
richard_f_20130930_972.jpg

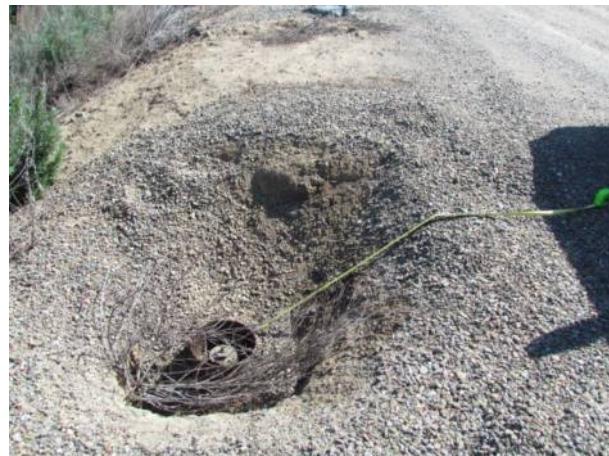
Levee Mile Report Line	7
Start Levee Mile	0.79
End Levee Mile	0.79
Location	Water Side
Category	Interior Drainage & Piping Systems
Item	Erosion Areas
Looking south at caving around siphon on waterside shoulder.(Spring 2012)	
richard_f_20130930_974.jpg

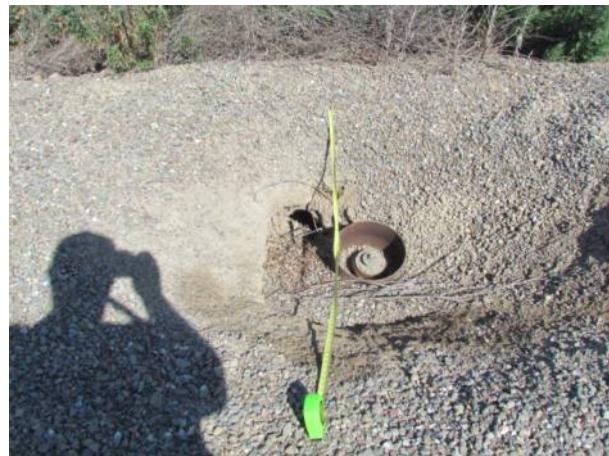
Levee Mile Report Line	7
Start Levee Mile	0.79
End Levee Mile	0.79
Location	Water Side
Category	Interior Drainage & Piping Systems
Item	Erosion Areas
Looking east at caving around siphon on waterside shoulder. (Spring 2012)	
richard_f_20130930_975.jpg

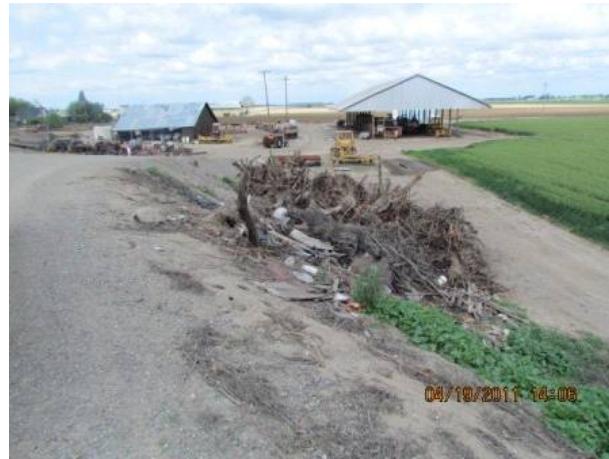
Levee Mile Report Line	9
Start Levee Mile	1.14
End Levee Mile	1.14
Location	Land Side
Category	Earthen Levee
Item	Encroachments
Looking southwest at pruning pile on landside slope.	
richard_f_20130930_993.jpg

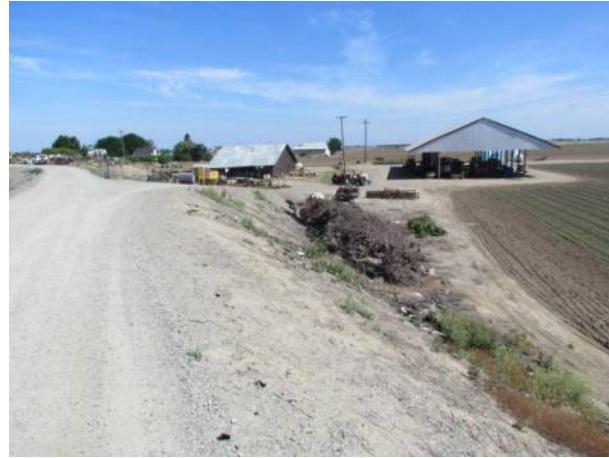
Levee Mile Report Line	9
Start Levee Mile	1.14
End Levee Mile	1.14
Location	Land Side
Category	Earthen Levee
Item	Encroachments
Looking southwest at garbage and pruning pile at landside toe.(Spring 2012)	
richard_f_20130930_994.jpg

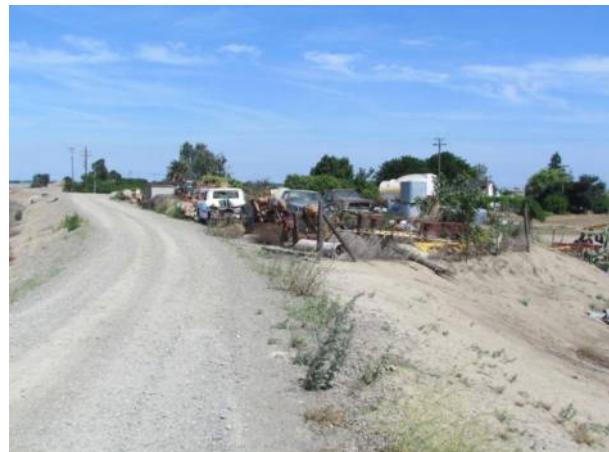
Levee Mile Report Line	11
Start Levee Mile	1.17
End Levee Mile	1.23
Location	Land Side
Category	Earthen Levee
Item	Encroachments
Looking southwest at vehicles and farm equipment stored on landside landing.	
richard_f_20130930_990.jpg

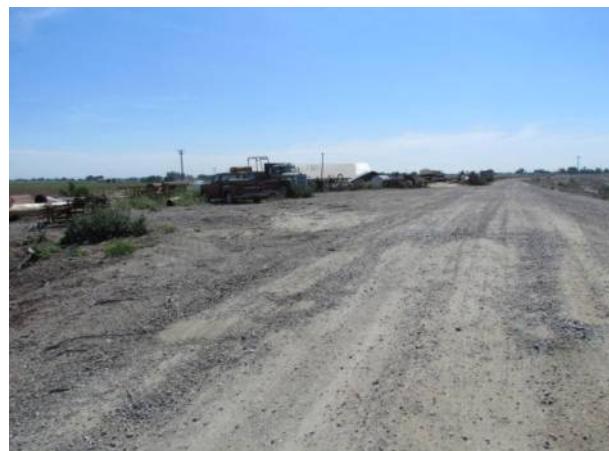
Levee Mile Report Line	11
Start Levee Mile	1.17
End Levee Mile	1.23
Location	Land Side
Category	Earthen Levee
Item	Encroachments
Looking northwest at vehicles and farm equipment stored on landside landing.	
richard_f_20130930_991.jpg

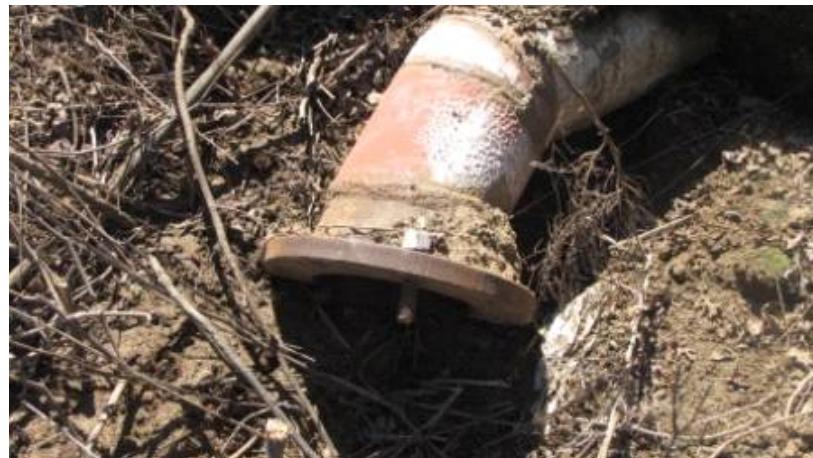
Levee Mile Report Line	15
Start Levee Mile	1.40
End Levee Mile	1.40
Location	Land Side
Category	Earthen Levee
Item	Encroachments
Looking east at pipe on landside slope.	
richard_f_20130930_995.jpg

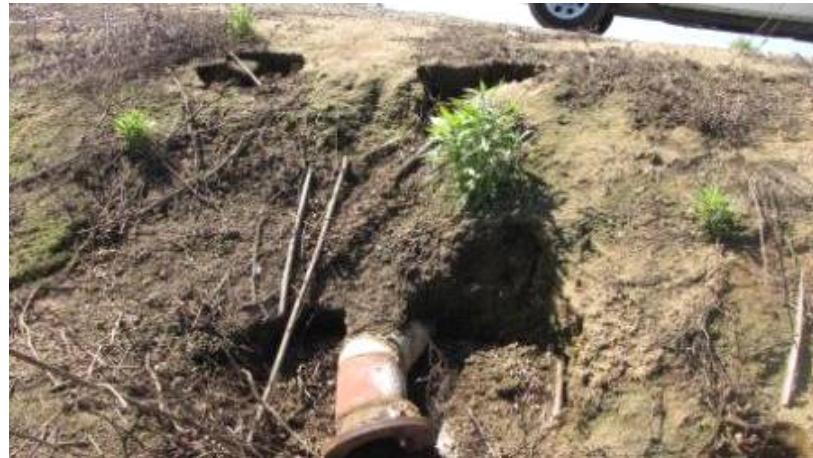
Levee Mile Report Line	15
Start Levee Mile	1.40
End Levee Mile	1.40
Location	Land Side
Category	Earthen Levee
Item	Encroachments
Looking east at pipe and erosion just above pipe on landside slope and shoulder.	
richard_f_20130930_996.jpg

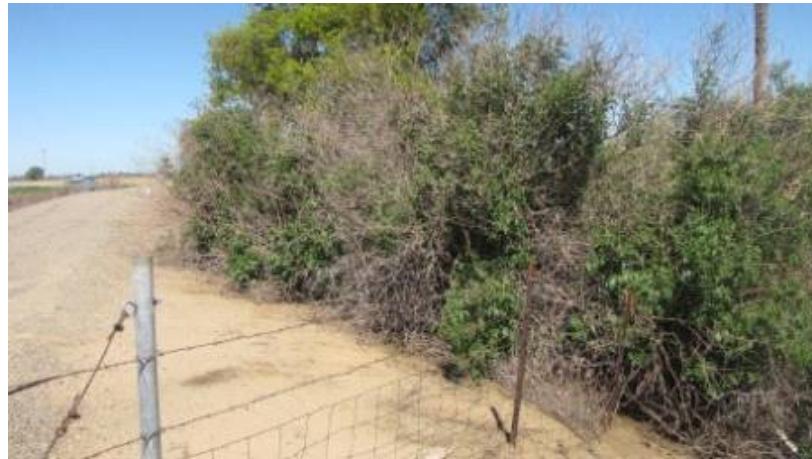
Levee Mile Report Line	16
Start Levee Mile	1.41
End Levee Mile	1.41
Location	Land Side
Category	Earthen Levee
Item	Vegetation
Looking south at elderberries on landside slope and toe.	
richard_f_20130930_978.jpg

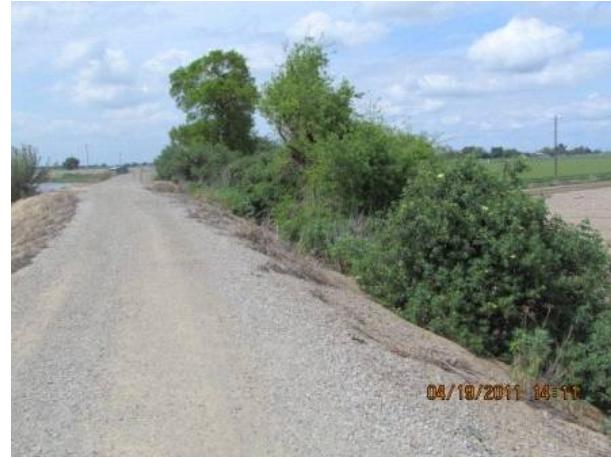
Levee Mile Report Line	16
Start Levee Mile	1.41
End Levee Mile	1.41
Location	Land Side
Category	Earthen Levee
Item	Vegetation
Looking southwest at elderberries on landside slope.	
richard_f_20130930_979.jpg

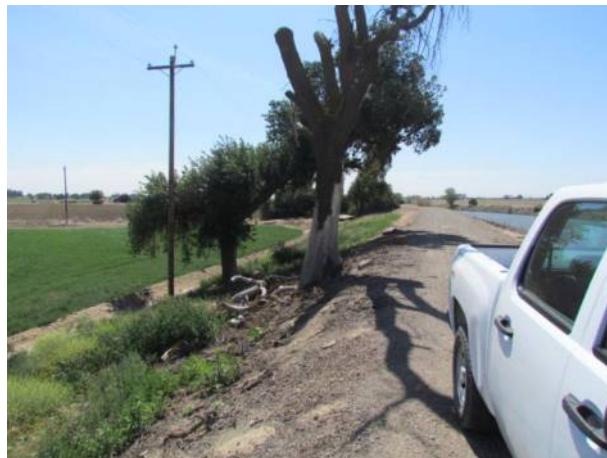
Levee Mile Report Line	19
Start Levee Mile	1.48
End Levee Mile	1.48
Location	Land Side
Category	Earthen Levee
Item	Encroachments
Looking north at dead tree and tree limbs on landside shoulder and slope.	
richard_f_20130930_999.jpg

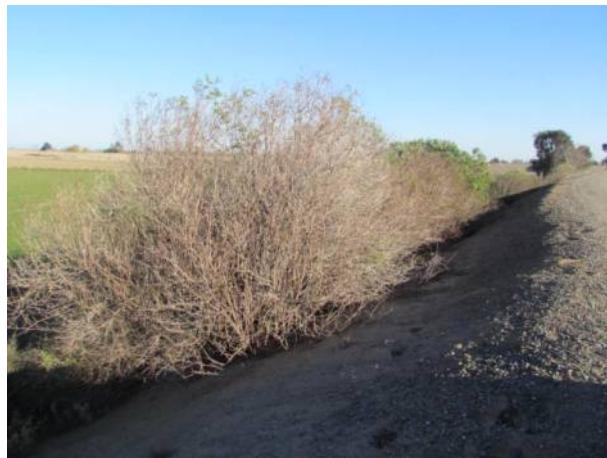
Levee Mile Report Line	24
Start Levee Mile	2.11
End Levee Mile	2.12
Location	Land Side
Category	Earthen Levee
Item	Vegetation
Looking northwest at elderberries on landside slope and toe.	
richard_f_20130930_982.jpg

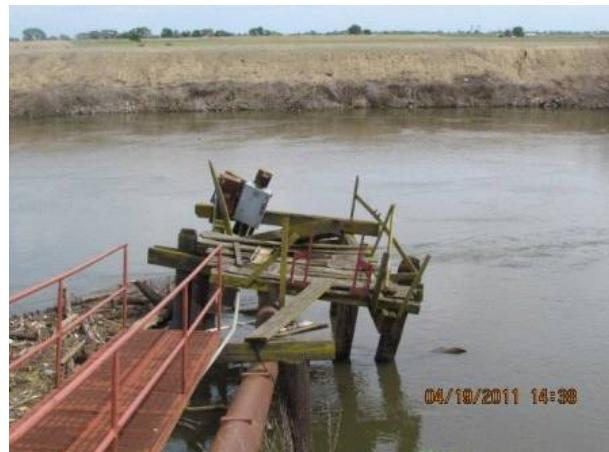
Levee Mile Report Line	32
Start Levee Mile	2.64
End Levee Mile	2.64
Location	Water Side
Category	Channels
Item	Encroachments
Looking east at dilapidated pump platform.	
richard_f_20130930_989.jpg

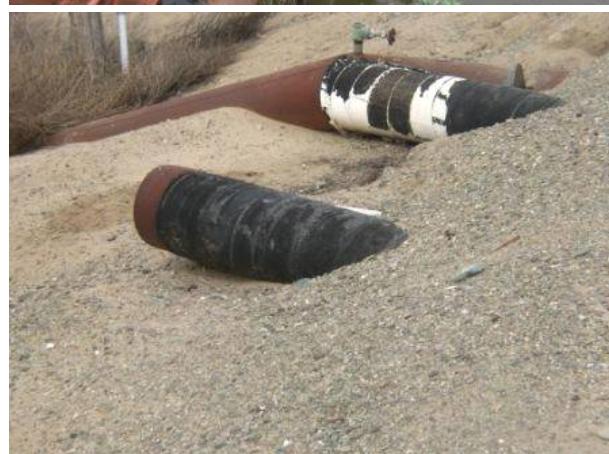
Levee Mile Report Line	33
Start Levee Mile	2.65
End Levee Mile	2.65
Location	Crown
Category	Earthen Levee
Item	Encroachments
Abandoned pipe at LM 2.65, landside view.	
richard_f_20130930_983.jpg
